# BELZONA REPAIRS CAVITATION DAMAGE ON POTABLE WATER PUMP.

ID: 1259

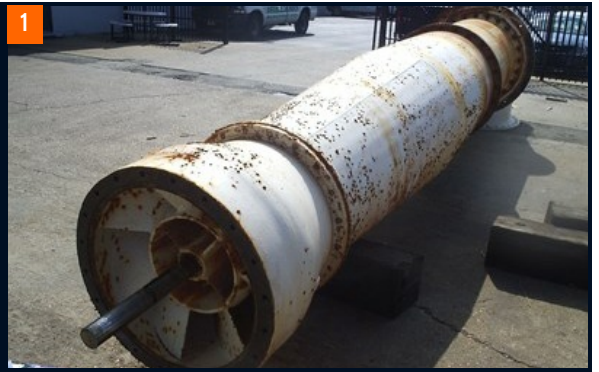
1. 24 inch vertical potable water Pump
2. Suction Bell shown with severe cavitation damage. Pump repaired with Super Metal
3. Pump back in shop vibration issues. Inspection shows minor damage to old repairs
4. Belzona Super E Metal used to repair minor cavitation damage.

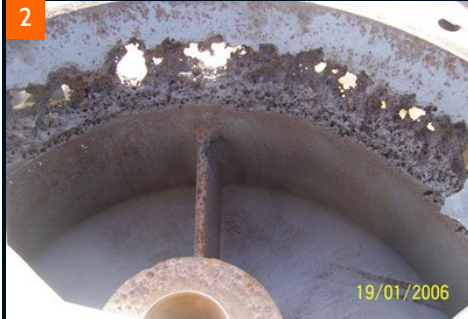
Suction bowl badly damaged by cavitation.

January 2006: Lost metal replaced with Belzona® 1111. Strength added to casing by welding steel stiffeners to outside of casing.  
April 2008: Pump back in shop for vibration. Old repairs inspected. Minor damage found. Minor damaged repaired with Belzona® 1221 and NSF approved Belzona® 1341 applied over Belzona® 1221.
