# CAVITATED PUMP DIFFUSER RESTORED WITH BELZONA

ID: 1261

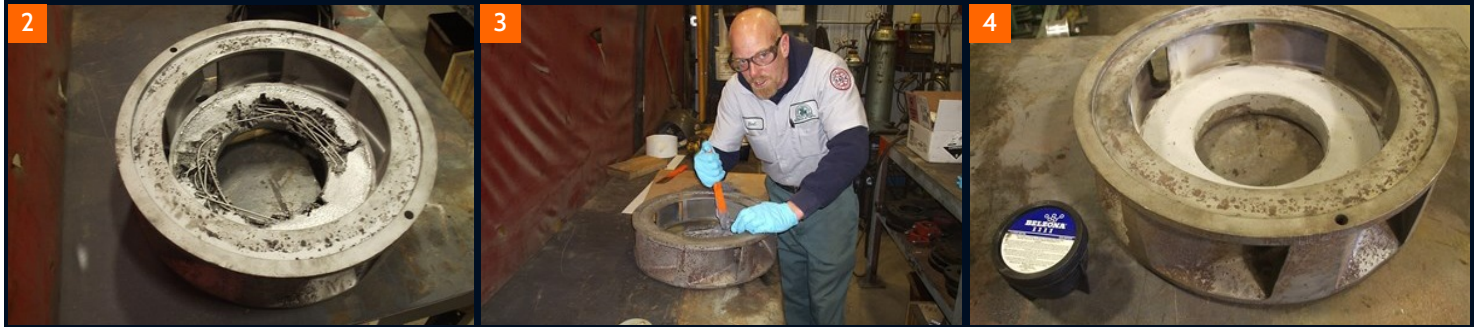
Cavitation had caused severe metal loss to pump impeller and diffuser. New impeller was available but no diffuser available.

1. Severely cavitated diffuser
2. Diffuser blasted and rebar tack welded in place
3. Belzona 1111 application
4. Completed repair

Application was carried out in accordance with Belzona System Leaflet CEP-1. Pump shop tack welded "rebar" into deeply cavitated areas. Belzona® 1111 applied to replace lost metal. Belzona machined to original diffuser dimensions.
