# STORM WATER PUMP PROTECTED WITH BELZONA FOR 10 YEARS

ID: 1262

Replacement new vertical storm water pump

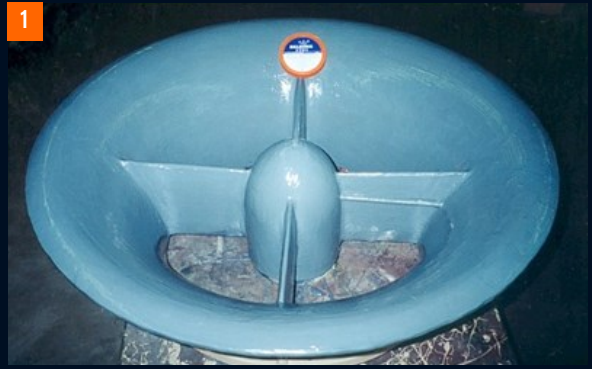
1. Suction Bell coated in 1998
2. Diffuser coated in 1998
3. Suction Bell in 2008
4. Diffuser in 2008

Application was carried out in accordance with Belzona Know-How System Leaflets CEP-3 and CEP-4. New pump was disassembled at local repair facility. Suction bell and diffuser blasted and coated with Belzona® 1321 internally and Belzona® 5811 externally.

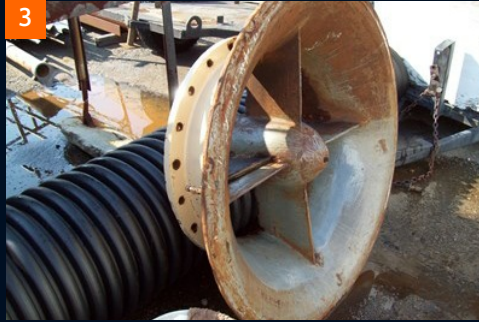
City personnel were very unhappy with the short service life of original vertical storm water pump. To protect the new pump from the damaging effects of the erosion corrosion cycle, Belzona coatings were applied. The new pump was retired after 10 years of successful service to replace it with a larger pump. An after service inspection revealed that 100% of the Belzona® 5811 was intact and 95+% of the Belzona® 1321 was intact.
