# EVAPORATOR BARREL PROTECTION WITH BELZONA

ID: 1264

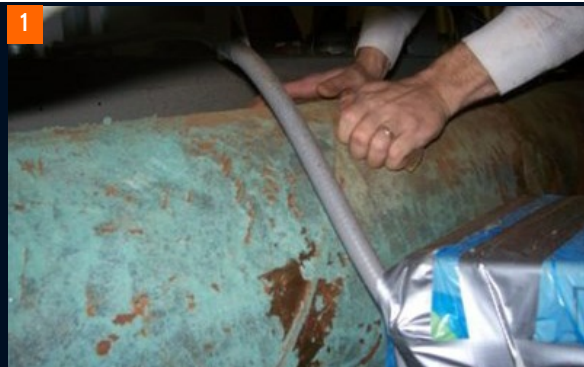
The evaporator barrel is corroding from the inside out and springing leaks, which causes a temporary shutdown to repair the leak. The customer wanted a solution that would allow them to keep operating should a leak occur until they could plan a shutdown for a more permanent repair or replacement.

1. Preparation of the barrel
2. Application of the first coat and reinforcing sheet
3. Completed application of second coat
4. Completed application

The application was carried out with a modified version of Belzona Know-How System Leaflet. An orbital sander with a scotch brite pad was used to lightly abrade the surface, which was too thin to achieve an ideal preparation. The surface was cleaned with MEK. A heavy coat of Belzona 2121 was applied, the barrel was wrapped with Belzona 9331 and a second heavy coat of Belzona 2121 was applied.
