# BELZONA PROVIDES LONG TERM REPAIRS TO CLARIFIER

ID: 1265

Main Clarifier of Sewage Treatment Plant.

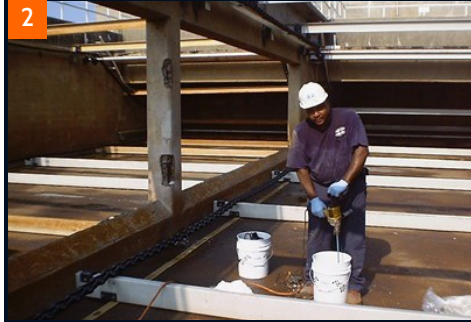
Severe cracks appearing in concrete walls and spalling concrete over re-bar on columns.

1. Spalled concrete on vertical column prepared and conditioned
2. Spalling on vertical columns being repaired with Belzona 4141
3. Cracks in Wall repaired with Belzona 4111
4. Picture of clarifier in 2008 after 5 years service

Application was carried out in accordance with Belzona Know-How System Leaflet TCC-9. Belzona® 4141 used to rebuild spalled columns and Belzona® 4111 used on cracked walls.

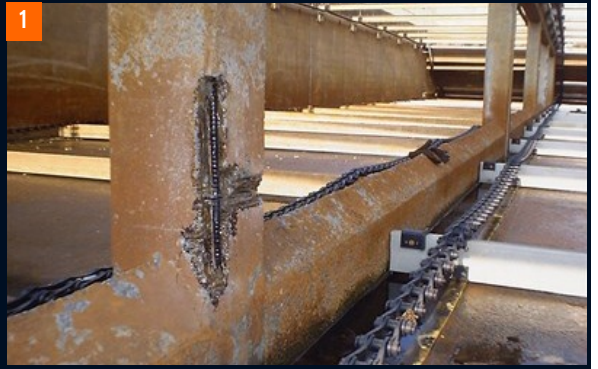
Customer previously used lower cost alternatives but did not last for long. These Belzona repairs in the Clarifier have been in service for 5 years without failure.
