# BELZONA REPAIRED RECYCLING DRUM LASTS 12 YEARS

ID: 1266

A paper mill recycling drum (30 long and 10 diameter) used to recycle newsprint. It operates 24 hours a day, 7 days a week at 120°F and pH 10-11.

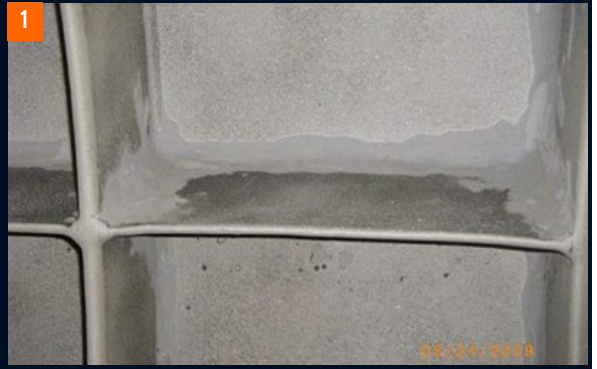
1. Remaining Belzona 1311 from application 12 years ago
2. Additional remaining Belzona 1311 from original application
3. Remaining Belzona 1321 from application 12 years ago
4. Additional remaining Belzona 1321 from original application

The application literally saved millions of dollars in replacement costs and downtime. The pictures show how much Belzona Ceramic R-Metal is left protecting the incompatible welds and Ceramic S-metal is left protecting the surface of the steel. Inspection of the application after 12 years of continuous service and sandblasting with coal slag proves that Belzona provided the right solution for the problem.
