# BELZONA SAVES RECYCLING DRUM FOR SECOND TIME

ID: 1267

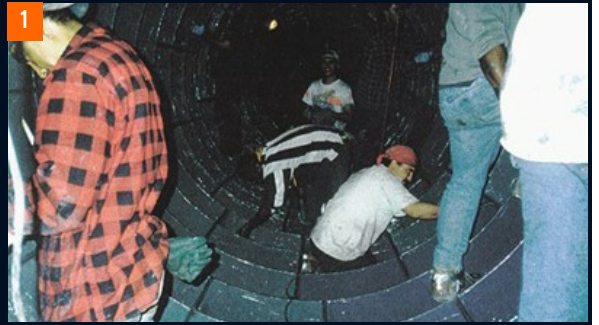
1. Original application in 1997
2. After grit blasting Belzona still protecting the critical welds after 12 years.
3. Belzona 1311 being applied
4. Completed project after application of Belzona 1321

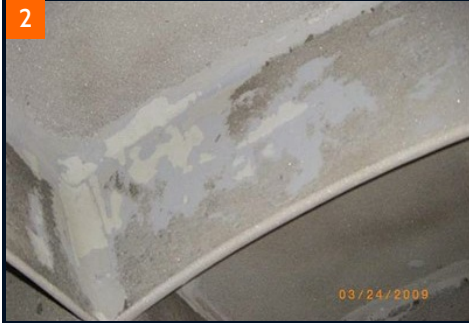
Bi-metallic corrosion on approximately 70% of the un-protected welds found in 1997. Belzona system applied and inspection of the application after 12 years proves that Belzona provided the right solution for the problem. Belzona was selected to be re-applied to further protect the drum.
