# CHURCH HAS LONG HISTORY WITH BELZONA

ID: 1268

Domed roof on Church.

Church, Richmond, Virginia USA

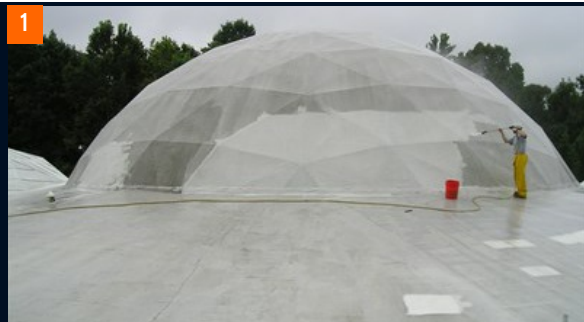
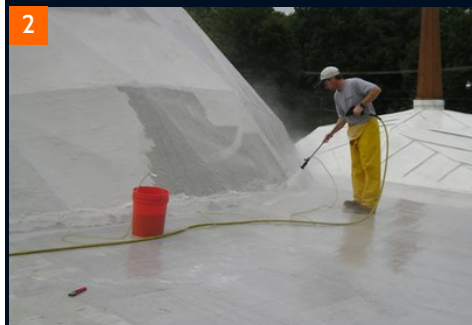
1. & 2. Applying Belzona Flexible Membrane
3. Spraying the top of the dome
4. The roof in 2006

Application was carried out in accordance with Belzona Know-How System leaflet RPA-1. Spray application was used to aid application.
