# BELZONA PROTECTS OIL GAS SEPARATORS

ID: 127

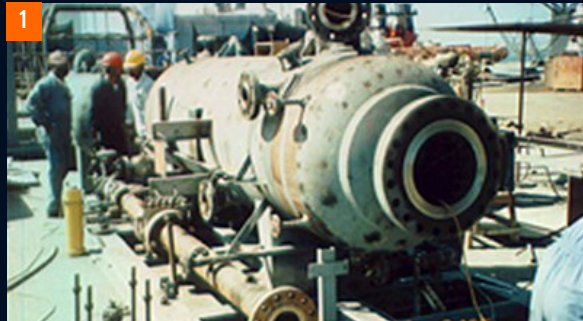
Severe deterioration to the internal surfaces of the vessels due to erosion-corrosion and SRB attack.

1. General view of separator
2. Application of Belzona 1391 underway in a confined internal space
3. Completed application to all internal surfaces of the separator
