# SUCTION BELLS RESTORED WITH BELZONA

ID: 1275

Suction bells from two cooling water pumps.

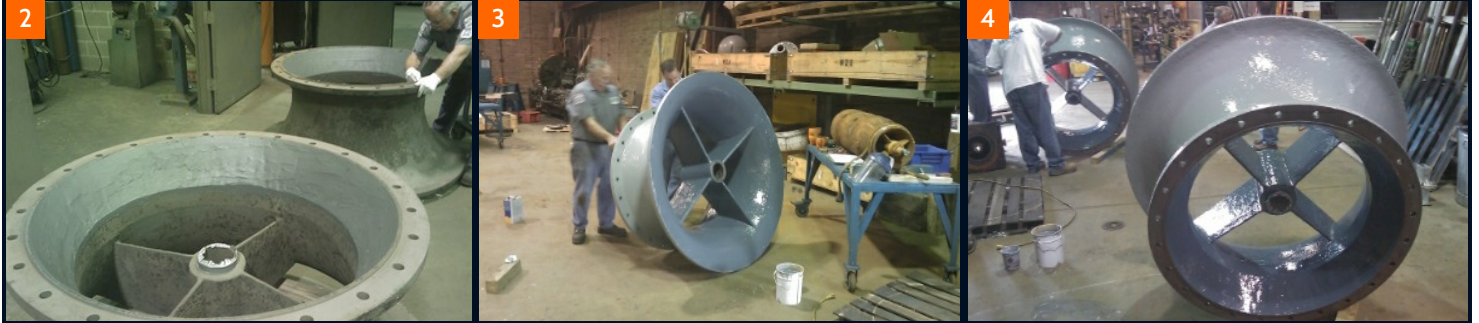
Erosion had caused serious loss of metal with holes completely through the substrate in places. Loss of efficiency and unscheduled downtime lead client to look at replacing the items.

1. Erosion clearly evident
2. Belzona 1311 being applied
3. Belzona 1321 applied to internal surfaces
4. Belzona 5811 applied to external surfaces

Bells were sandblasted to a white to near Application was carried out in accordance with Belzona System Leaflets CEP-3, CEP-4, and CEP-5. Belzona® 1311 applied to bring housing back to original dimensions. The internals were then coated with Belzona® 1321 and exterior with Belzona® 5811.
