# FLOW CONTROL VALVE REFURBISHED WITH BELZONA

ID: 1276

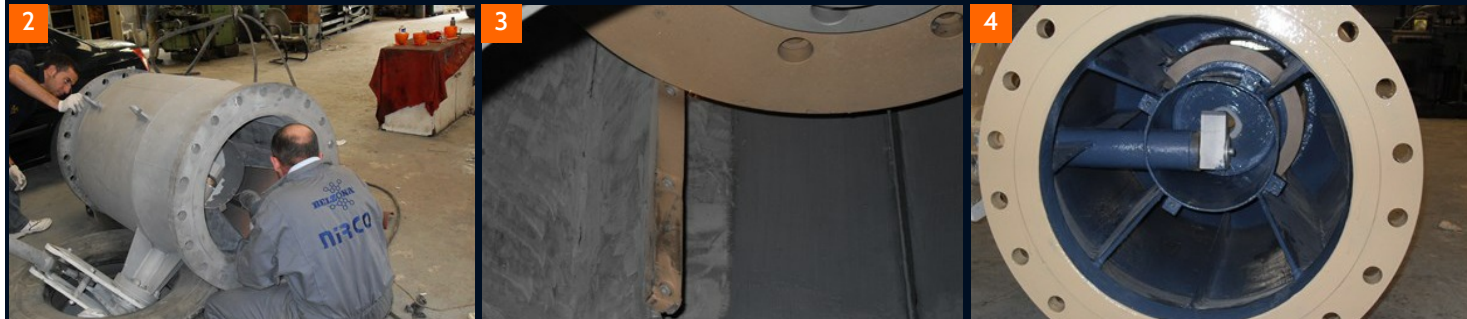
Corrosion and erosion on internal surfaces caused by sewage water.

85cm diameter control valve at the biggest wastewater treatment plant in Jordan.

1. General view of the valve
2. Rebuilding internal surfaces
3. Internal surfaces rebuilt and half coated
4. Valve coated internally and externally

Application was carried out in accordance with Belzona Know-How System Leaflets CEP-3, -4 and -5.

Belzona 1111 (Super Metal) Belzona 1311 (Ceramic R-Metal) Belzona 1321 (Ceramic S-Metal) Belzona 5811 (Immersion Grade)
