# EMERGENCY LEAK SEALING ON TRANSFORMER WITH BELZONA

ID: 1278

Leaks of transformer oil on porous and cracked welds

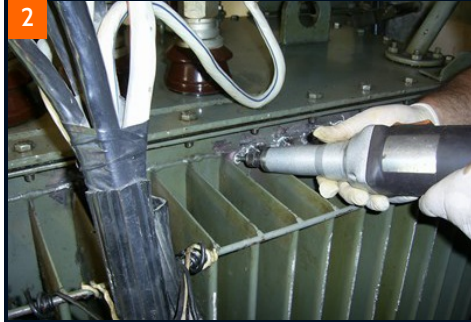
450 kVA transformer for the electrical supply of the local water pump station.

1. General view of the transformer
2. Close view of surface preparation
3. Belzona 1291 applied to stop live leaks
4. Belzona 1161 applied over the problem area
