# BELZONA STANDARD PROTECTION OF SCREW CONVEYOR FOR SOAP PRODUCTION

ID: 1279

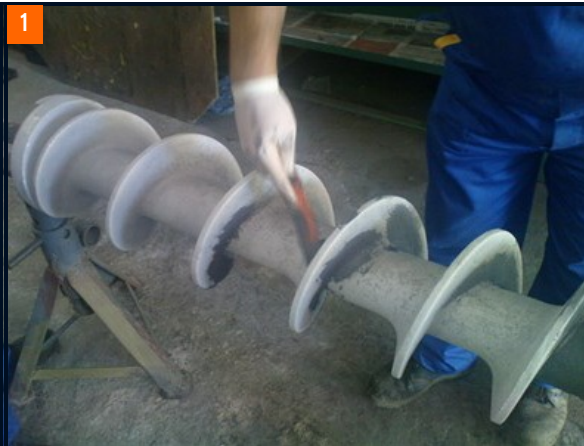
Erosion/corrosion causes pitting damage on screw conveyor surface accentuated by the high working temperatures (more than 60°C), high pressure injection and corrosive chemical process media.

1. Surface damages repaired with Belzona 1111
2. First coat of Belzona 1392 (red) completed
3. Second coat of Belzona 1392 (grey) completed
4. Inspection of screw after two months in working conditions

Application was carried out in accordance with Belzona Know-How System Leaflet SHM-14. Surface preparation was made in accordance with the Colgate-Palmolive procedure in Belzona approvals (Refurbishing and Coating Silumin Worms for Soap Plodders).

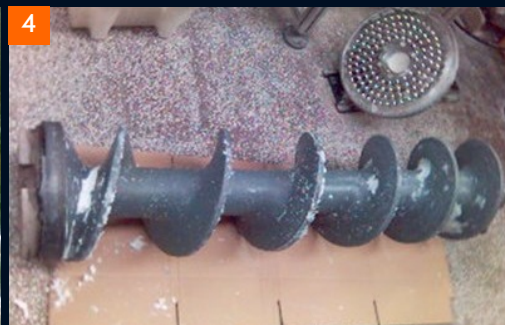
Two screw conveyors with OD 250 mm and 300 mm were protected with a third to be completed. Inspection review two months after application revealed only slight discolouring and loss of gloss. Belzona is routinely specified by this International soap producer for protection of these screws.
