# BELZONA REBUILDS BEARING SUPPORTS ON HUGE EXCAVATOR

ID: 128

Erosion of support surface for crown bearing

Crown bearings of rotational platform of large excavator (superstructure over 400 tons).

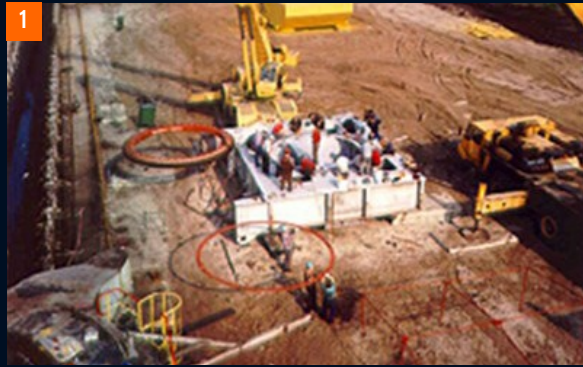
General view of the excavator partially dismantled for maintenance  
Application of Belzona 1111 A team of applicators was required to apply all the Belzona 1111 quickly, to allow time for the rings to be located

The technique allows for 100% support of the bearing and also allows for future replacement, should the bearing fail. The bearing used in this application was a new one.
