# BELZONA REBUILDS OVERSIZED PINTLE HOUSING

ID: 1281

Keyway and rudder pintle housing were oversized due to erosion corrosion and impact.

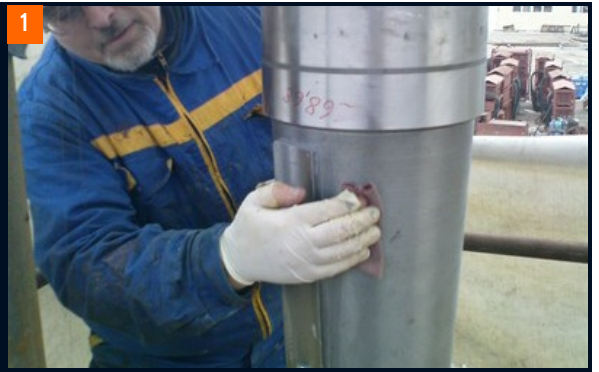
1. Rudder pintle with false key used as former
2. Adjusting unit for rudder pintle positioning
3. After application of Belzona 1111 the rudder stock was positioned
4. The oversized housing and keyway restored to exact profile

Application procedures were made according to Belzona Know-How System Leaflet SOS-3. The oversized housing and keyway were rebuilt using the rudder pintle with a false key as former. Belzona® 1111 was used for the main repair and Belzona® 1221 was used to fill some voids along keyway.
