# BELZONA RESEATS BEARING BUSHES IN STEERING GEAR

ID: 1282

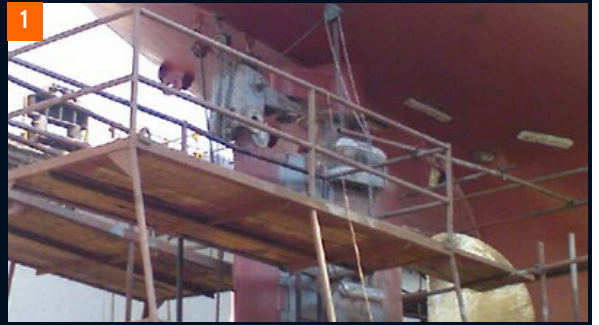
1. General view of the rudder steering system
2. Close view of the worn housing after blasting
3. Reseating of the new bronze bush at the exact position
4. Injection of Belzona 1321 through injection ports in side flanges completed

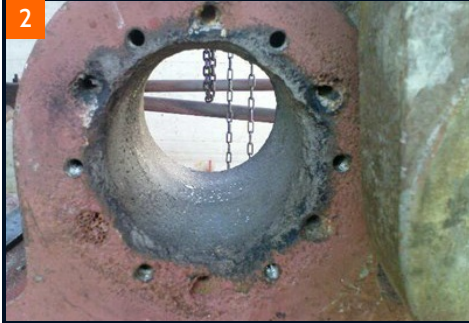
Bimetallic corrosion caused wear of bush housing with further damage caused by the increased vibration in the rudder steering system.
