# BELZONA REBUILT HEAT EXCHANGER COVER

ID: 1283

Top-cover of heat exchanger

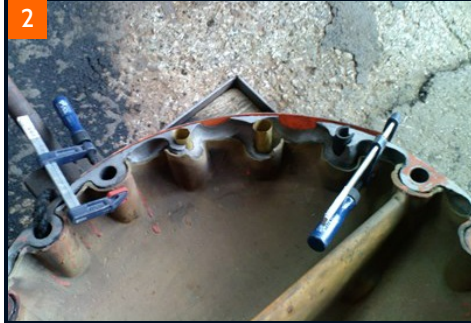
Damage on the original profile of the cooler top-cover due to erosion/corrosion, led to leaks and loss of efficiency.

1. Damage to top-cover clearly evident
2. Formers were used to restore profile
3. Repair of top-cover flange face in progress
4. Finished repair

Application was carried out in accordance with Belzona Know-How System Leaflet HEX-2. After blasting the damaged area and flange surfaces of the top-cover were restored by forming technique and Belzona® 1111.
