# BELZONA OPERATES IN THE DESERT

ID: 1287

## PROBLEM

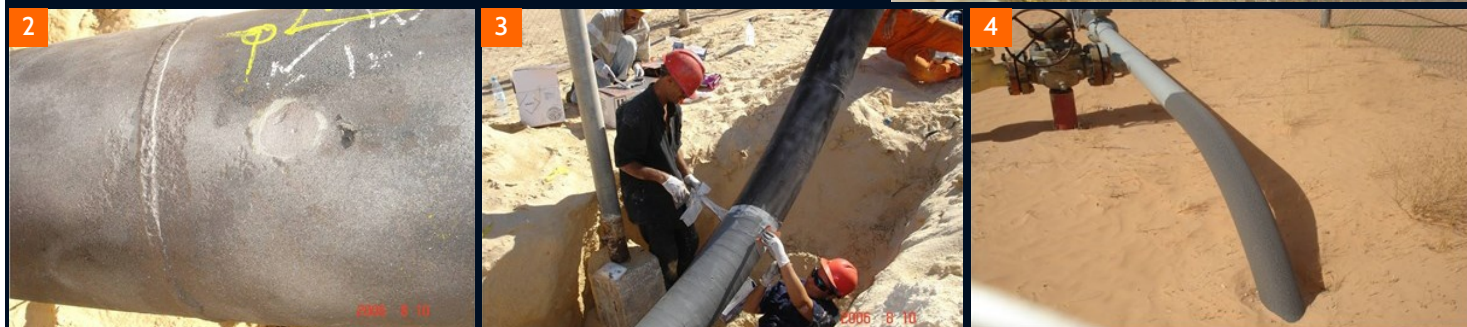
## PHOTOS

Pipeline was highly corroded due to external corrosion. Over 60% wall loss was measured on the pipe. Isolating the pipe to change this corroded section would cost millions in production loss.

1. Corroded pipeline before blasting
2. Blasted substrate
3. Application being carried out
4. 2 years later

Application was carried out in accordance with Belzona Know-How System Leaflets VPF-11a & TCC-5. Following grit blasting, Belzona 1121 with reinforcement sheet was used to rebuild the wall loss. Belzona 5811 was applied over the repair area to offer corrosion protection.

This repair was completed online and with ambient temperature of 55°C (131°F). and avoided production losses. Following this application, an independent inspection company has approved the repair. 2 years later, the pipe is still in perfect condition and the customer is considering extending the Belzona solution to other sections of the pipeline.
