# BELZONA RETURNS PIPELINE PIG BACK TO SERVICE

ID: 1288

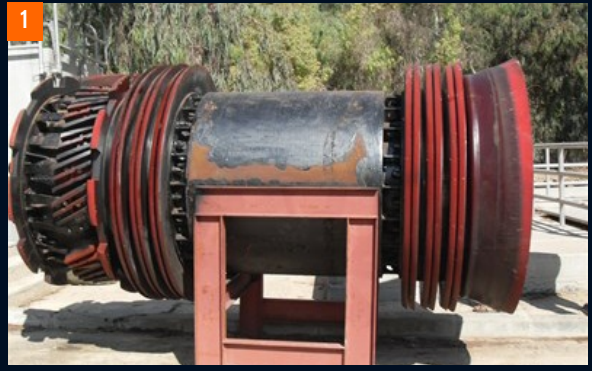
The pig (scraper) travels more than one hundred kilometers inside huge wastewater pipes to keep walls clean.

1. General view of the pig
2. View of the worn area
3. Rebuilding surface with Belzona 2111
4. Application is finished and the responsible engineer inspects the application

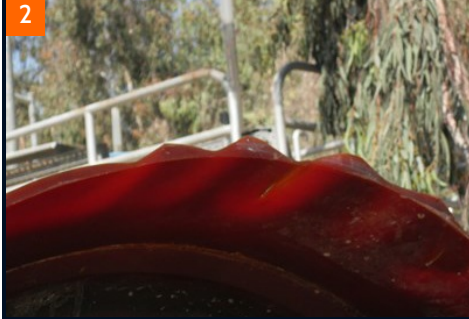
Wear on the rubber tail causes imbalance in the pig.
