# BELZONA REBUILDS STERN TUBE BEARING SUPPORTS IN MINIMUM TIME

ID: 129

U.S. Coast Guard Ice Breaker, Seattle

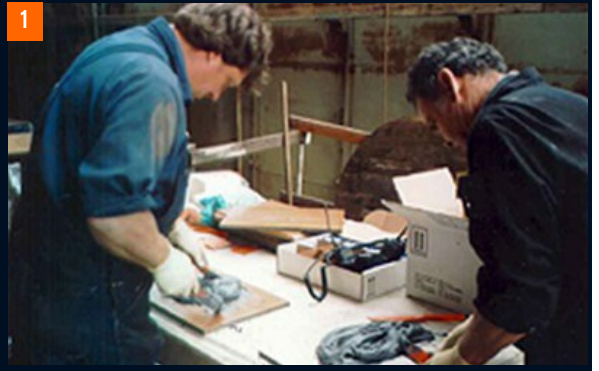
1. It takes a stalwart crew to mix 300kg of Belzona 1111 in only a few hours
2. Great care was taken to ensure the substrate was correctly prepared prior to the application of Belzona products
3. Application of Belzona 1111 to rebuild the bearing retaining lands

Application was carried out in accordance with Belzona Know-How Leaflets SOS-9 and MPT-6. Belzona® 1111 was applied at an average thickness of ½" (12.5mm). When cured, the stern tube lands were bored to the desired step dimensions.
