# BELZONA PROVEN PROTECTION OF STEAM TURBINE

ID: 1290

Vladimirsky Power Plant/ Russia

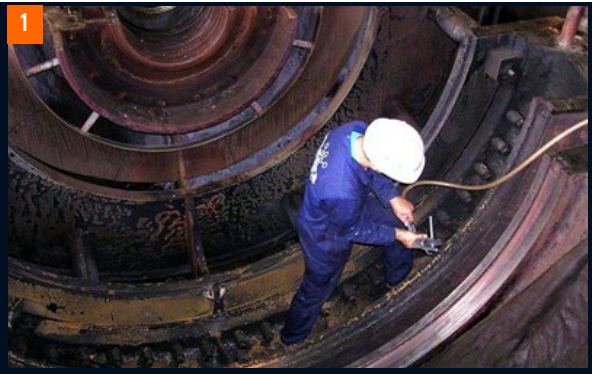
1. Grit blasting underway
2. After blasting extent of damage clearly evident
3. Application of Belzona 1391
4. Completed job

Application was carried out in accordance with a modified version of Belzona Know-How System Leaflets CEP-3 & -5.

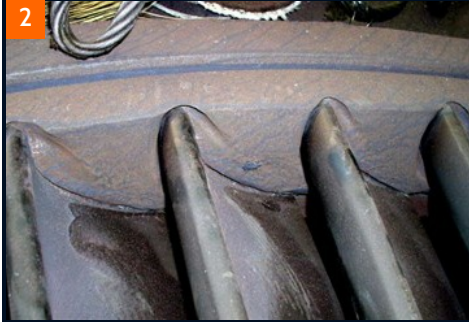
After more than 35 years (253.000 hours) in-service, inspection during shutdown in 2003, revealed that turbine faced severe stream erosion caused by humid steam. Damages were up to 8 mm wide and 10 mm deep.
