# BELZONA PROVIDES POSITIVE GRIP TO DRIVE ROLLER

ID: 1292

Conventional rubber cladding conveyor drive roller (diameter 800 mm and length 1400 mm) for transporting fertilizer production

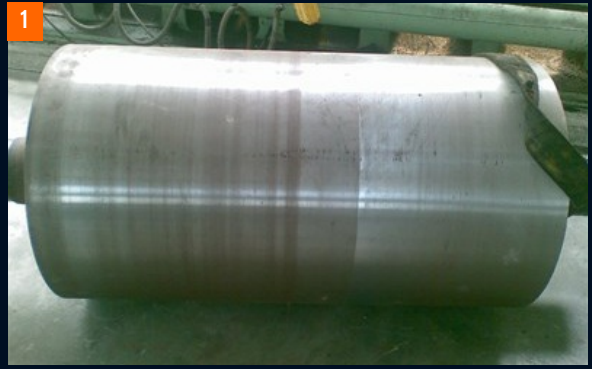
Pieces of rubber cladding were frequently torn away due to build up. In addition severe wear from excessive moisture, chemical attack and abrasive media was causing belt slippage.

1. Drive roller with just removed old rubber cladding
2. Grit blasted drive roller
3. Belzona non-slip chevron designed surface being applied
4. Completed application and drive roller ready for service
