# BELZONA KEEPS THE LIGHTS BURNING

ID: 1294

Bushing of both blue and red phase of 330KV oil filled transformer. This is a major unit responsible for power supply to a major part of the city.

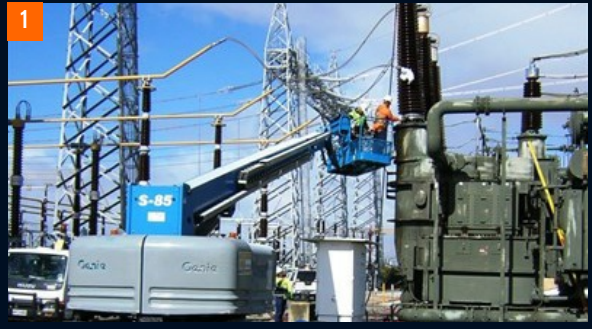
The seal around ceramic bushing had degraded allowing oil to leak out which in turn reduced the operational efficiency of the unit.

1. General view of site with access from mobile platform
2. Application of Belzona 1161 applied in conjunction with Reinforcement tape
3. Completing the application
