# BELZONA PROTECTS ION-EXCHANGE FILTER

ID: 1295

Interior coating of ion-exchange filter used to produce water for boilers

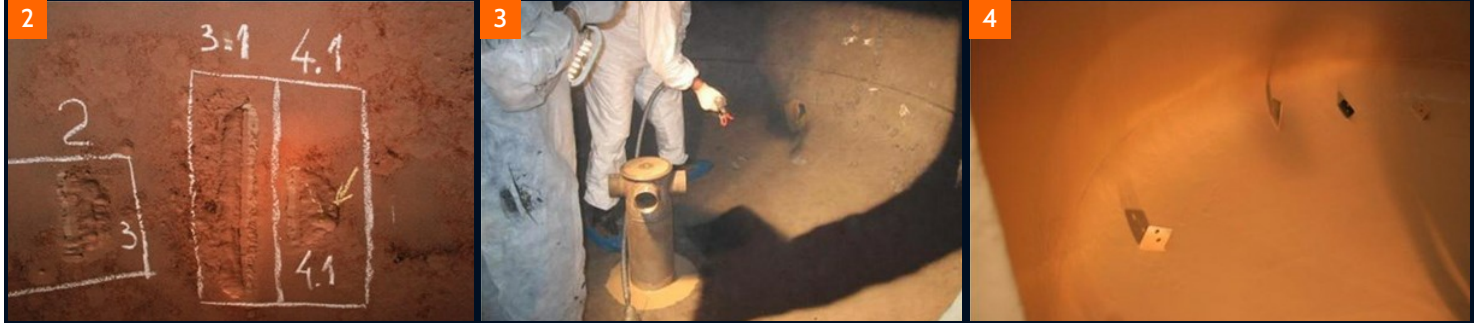
There were blisters, holes and layer of salts under the original polymeric coating after more than 50 years of service. When old coating was removed many corrosion pits in the substrate were detected.

1. Inside the filter
2. Damaged areas within the filter
3. Spraying Belzona 5811
4. Completed application

Application was carried out in accordance with Belzona Know-How System leaflet TCC-5. Deep holes were welded. Small areas of corrosion pitting was rebuilt with Belzona 1111. Coating was applied by heated airless spray.
