# BELZONA RENOVATES PUDDLE PIPES

Corrosion on seawater inlet pipe to cooling system for nuclear power station.

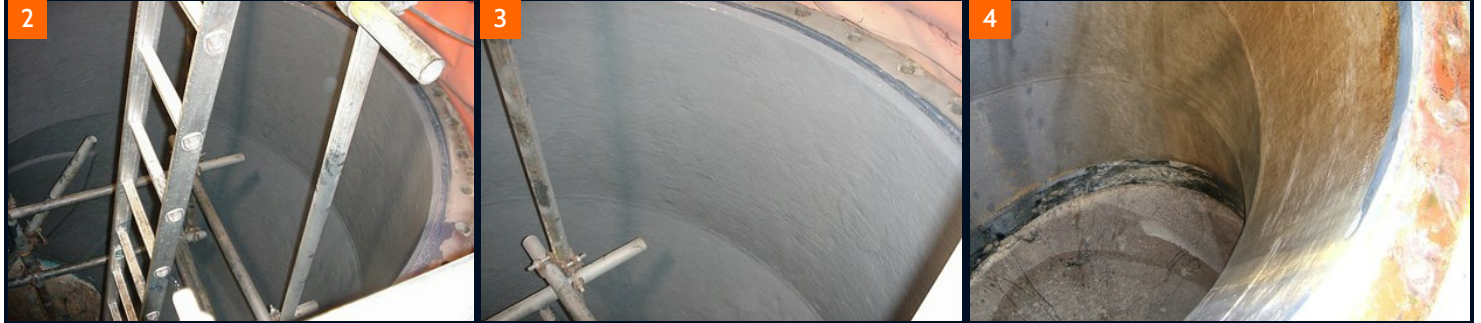
Corrosion affects these pipes where the concrete pipe in the sea connects with the steel pipe into the power station and the previous ceramic based products had failed to give the level of protection that was needed. Very regular coating was needed to keep the situation under control.

1. Scope of work
2. Top section complete
3. The finished surface
4. Inspection after 3 years shows no erosion damage

Application carried out in accordance with Belzona System Leaflets VPF-1 and -2. A four coat system was adopted by the Power Station to maximise longevity.

Before full scale application, trials were carried out with Belzona system pitted against 2 alternative suppliers (both ceramic based products). Belzona was found to be the clear winner when it came to erosion corrosion protection and therefore best value for money. Examined after 3 years no sign of erosion found. No problem seen in achieving required 6 year life. Previous recoating was carried out every 2 years.
