# BELZONA SEALS HYDRAULIC LEAK

ID: 1297

Hydraulic system of press for stone products

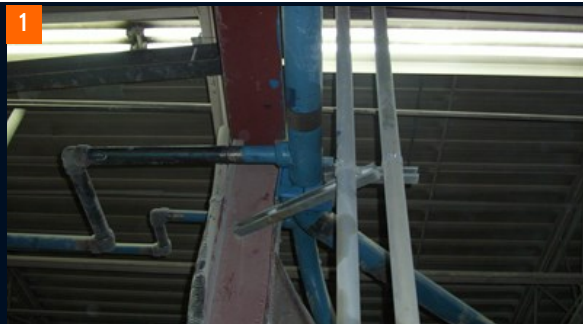
Hydraulic pipe had started to leak causing the fluid to drip onto the electrical circuit panel, causing a shutdown.

1. Leaking weld joint
2. Surface preparation
3. Completed repair

Application was carried out in accordance with Belzona Know-How System Leaflet VPF-11a. A wrap using the Belzona® 1111 with Belzona® 9341 (Reinforcement Tape) was used to encapsulate the leaking weld.
