# BELZONA ON EVAPORATOR TUBE SHEETS

ID: 13

Evaporator tube sheet.

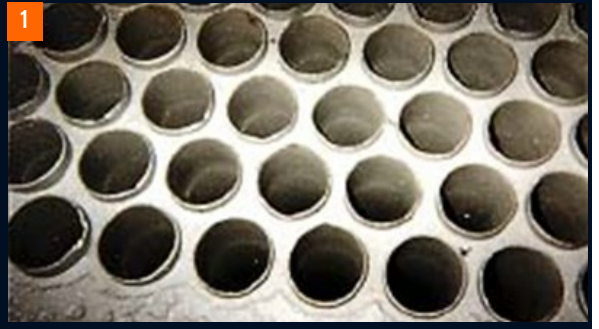
Erosion / corrosion of the tube sheet due to hot caustic black liquor at approximately 185°F and galvanic corrosion between the stainless steel tubes and mild steel tube face.

1. View of tube sheet showing erosion.
2. Application of Belzona 1391 via injection pistol to top tube sheet. Product was brushed into place around tubes and allowed to flow level.
3. Tube sheet inspection of Belzona 1391 after 2 years in service.

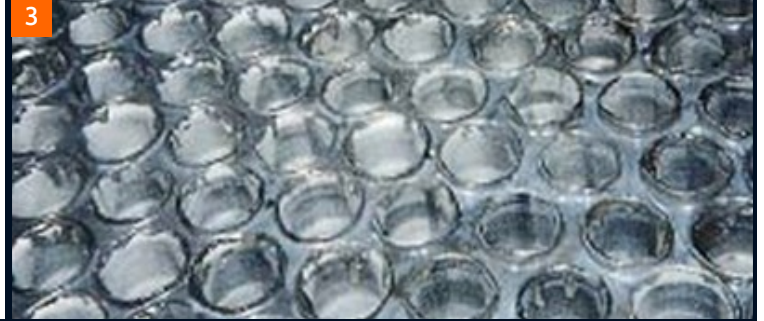
Belzona has been providing protection for evaporator tube sheets at this mill since April 1992. All three applications are still in service. The first application utilized Belzona® 1321, and while the coating has now since eroded away the Belzona product is still adhering in the "grooves" around the tubes, reducing erosion in this area dramatically. The application is scheduled to be refurbished. The other two applications are just short of 3 & 4 years old respectively. A fourth application (new) is planned.
