# BELZONA RECTIFIES LEAKAGE PROBLEM IN A BIOREACTOR CLARIFIER

ID: 131

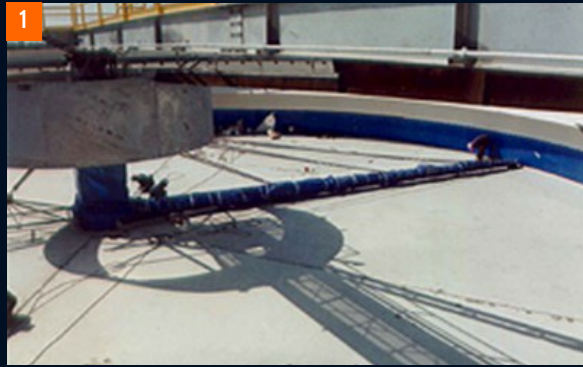
1. Concrete being repaired with Belzona 4111
2. First coat of Belzona 5811 being applied
3. Expansion joints masked off and pouring of Belzona 2221 commenced
