# BELZONA RECLAIMS HYDRO-ELECTRIC UNIT IN TEA PLANTATION

ID: 132

Small hydro-electric power unit

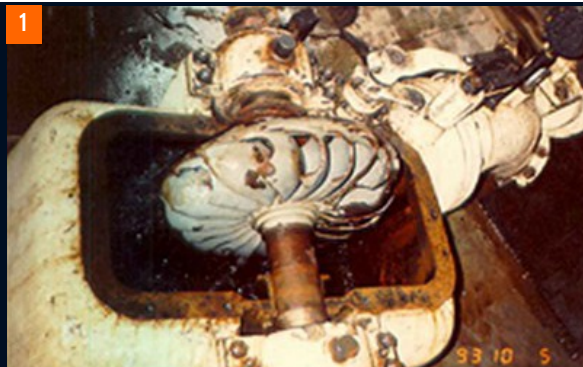
Power plant had ceased to be used due to the damaged runner blades. The cost of a new runner was too high to be economic.

1. The corroded runner in-situ
2. Surface preparation complete, the rebuilding can begin
3. The finished job ready for reassembly

Application was carried out in accordance with Belzona Know-How Leaflets CEP-6, CEP-5 and CEP-3.
