# BELZONA SAVES MONEY ON THE REPAIR OF A TRUNNION

ID: 133

Trunnion bearing

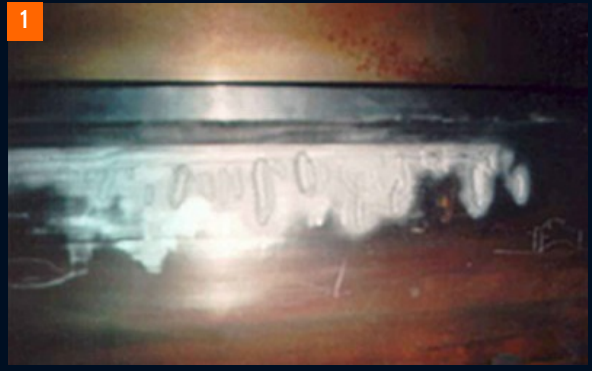
The seal area of a trunnion bearing had been badly scored by the ingress of foreign matter behind the seal.

1. Damaged seal area
2. View of trunnion bearing
3. Repair successfully completed

In accordance with Belzona Know-How Leaflet MPT-3.

Belzona 1111 (Super Metal)
