# TRANSFORMER LEAK SEALED WITH BELZONA

ID: 1331

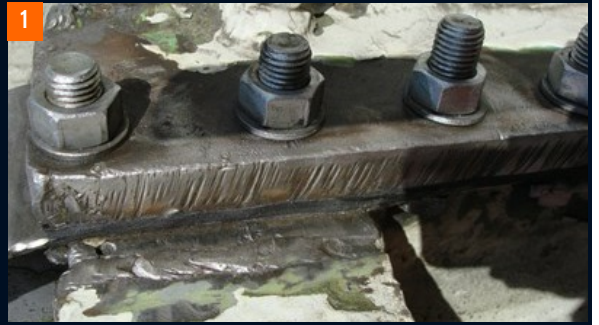
Transformer was leaking oil through the flanges.

1. Paint and other contamination removed
2. Substrate roughened
3. Belzona 1161 and Reinforcement Tape applied
4. Second layer of Belzona 1161

Application was carried out in accordance with Belzona Know-How System Leaflet TCC-1.
