# BELZONA PROTECTS KORT NOZZLES

ID: 1332

Pair of kort nozzles on tug boat

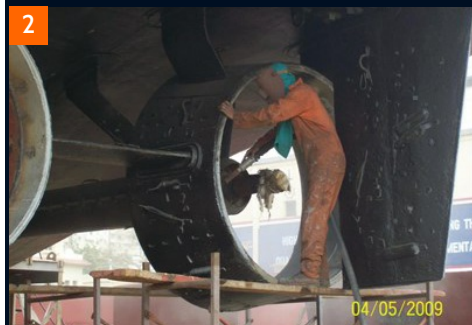
The Kort nozzles were suffering badly from erosion corrosion.

1. The boat in dry dock
2. Grit blasting the nozzles
3. Applying of Belzona 1321
4. Completed application

Application was carried out in accordance with Belzona Know-How System Leaflet SOS-2.
