# BELZONA RESCUES KOMATSU LOADER

ID: 1334

Komatsu transmission casing

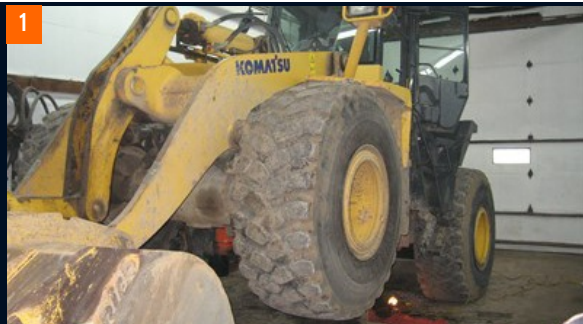
Loader drove over rock and cracked the casing in many areas

1. Loader
2. Cracked transmission casing
3. Preparation of casing
4. Belzona 1161 after application

After trying welding the cracks the oil in this casing continued to leak. That's when Belzona® 1161 came to the rescue. Cost of repair \$1500 vs Komatsu dealer repair over \$20,000. Loader still running after 10 months of operation maintenance free.
