# BELZONA KEEPS TIRE ROLLING

Damage on tire sidewall was exposing steel reinforcement to corrosion

Mine, Canada

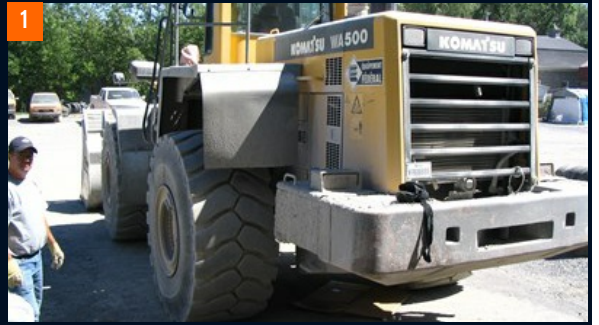
The equipment Crack was veed out and prepared with Belzona roughing brush Belzona 9341 (reinforcement Tape) incorporated for additional strength The completed repair
