# BELZONA REPAIRS AND PROTECTS 18 FOOT DIAMETER FLANGE FACE

Flange on 18ft. diameter evaporator.

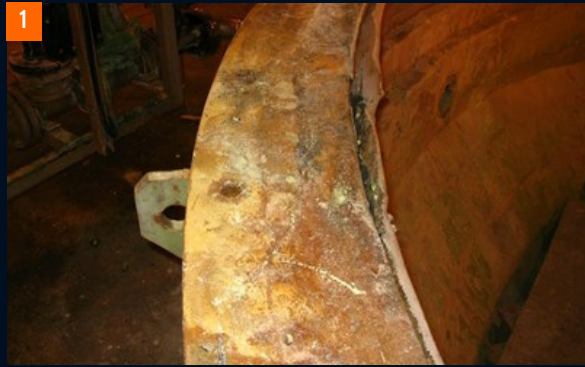
Flange was attacked by 98% Sulfuric acid at elevated temperature after Teflon lining was damaged.

1. Metal flange needed rebuilding.
2. The damaged Teflon lining that caused leak
3. The rebuilt flange protected with Belzona 4341

Application carried out in accordance with Belzona Know-How System Leaflets GSS-8 and HEX-3. Templates were used to obtain original profile of the flange with Belzona® 1111. Belzona® 4341 was applied as a protective coating.
