# BELZONA FLOOR UPGRADE PROVIDES ENVIRONMENTAL PROTECTION

ID: 1340

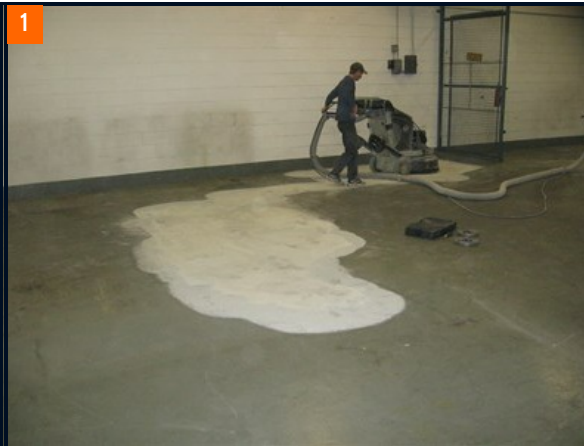
1. Floor being abraded
2. Aluminium angles sealed with Belzona 1121
3. Belzona 5811 being applied
4. Completed application
