# BELZONA RESEATS WEAR RINGS WITHOUT MACHINING

ID: 1341

Wear rings of a Worthington pump needed repairs on site.

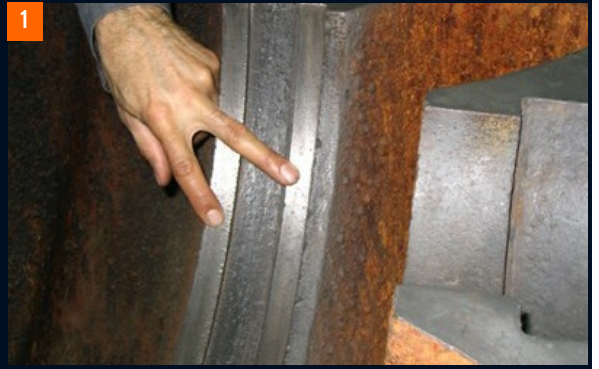
Erosion of wear ring seats caused vibration to the pump which needed repairs on site.

1. The wear ring seat
2. Release Agent applied to wear rings assembled on impellor
3. Surface preparation underway
4. Final result: no machining required

Application was carried out in accordance with Belzona Know-How System Leaflet CEP-2. The wear rings were located on the rotating element and used as former for the seats.

Belzona® 1121 allowed rebuilding of the wear ring seats to the original profile without machining. Belzona® 1121 is solvent free and does not shrink during cure allowing exact forming of the seat. Also being an insulator Belzona® 1121 eliminates any future galvanic corrosion.
