# BELZONA KEEPS GARAGE SAFE AND CLEAN

ID: 1343

Concrete floor in Public Works garage.

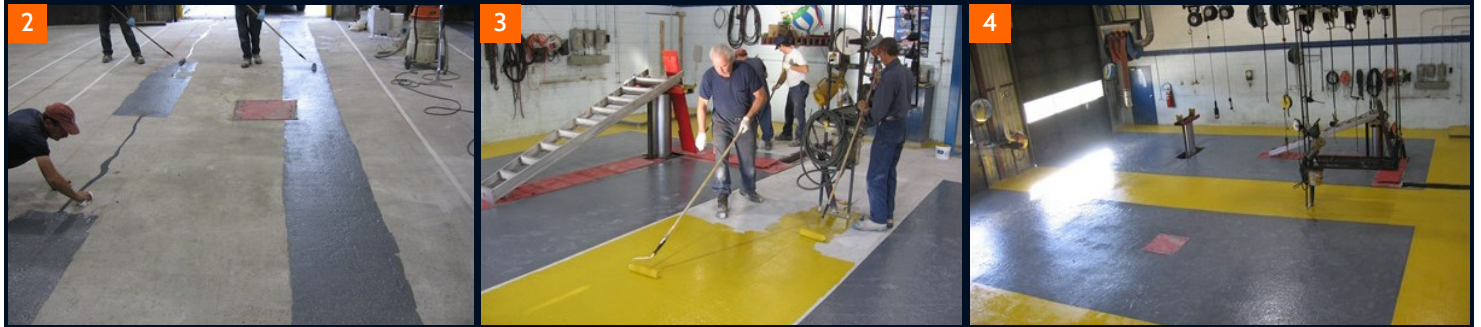
## PHOTOS

1. Surface preparation using Blastrac
2. Application of Belzona 5231 gray (3 coats)
3. Application of Belzona 5231 yellow
4. Completed application, clean and safe

Application was carried out in accordance with Belzona Know-How System Leaflet FPA-3. The concrete was abraded to remove the existing coating and profile the concrete. Areas masked off and Belzona® 5231 Yellow and Gray used for demarcation.
