# BELZONA FIXES DRAINAGE PROBLEM

ID: 1345

Parking garage storm drain

Office Building, Ontario Canada

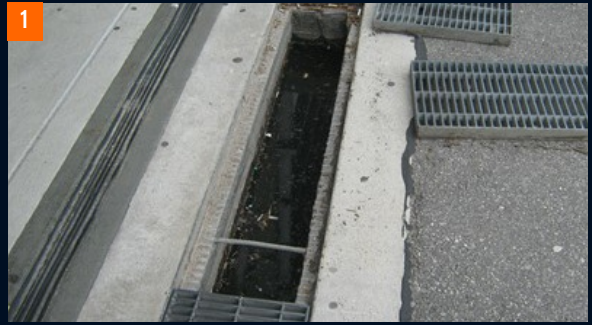
Previously installed coating system had failed and was stopping the water or anything else from draining out.

1. Water and trash not able to escape
2. Removing the old system
3. Grinding back to white concrete
4. Belzona 5811 applied
