# BELZONA RECONSTRUCTS STREET SWEEPER FAN

ID: 1348

Fan from a Busher type sweeper truck

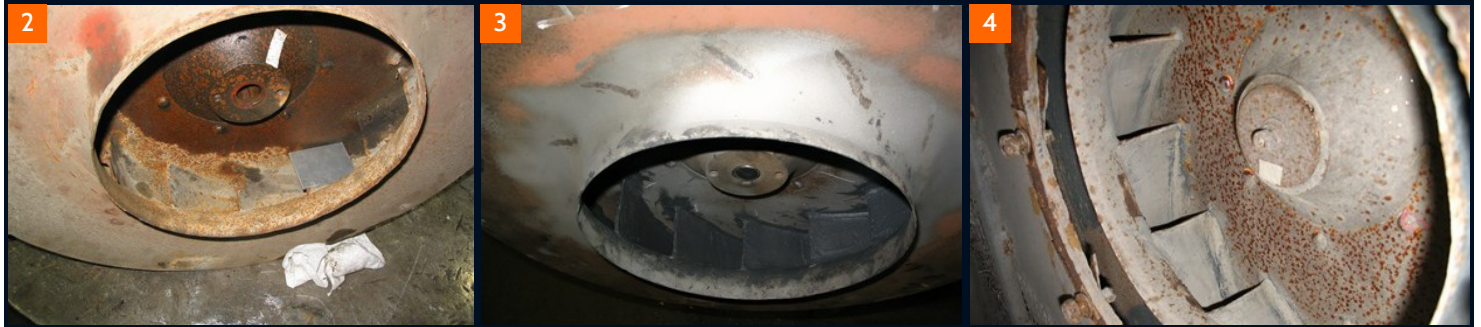
Wear on the blades of the fan. Customer wanted to avoid replacing the part.

1. Overall view of the fan and the wear on the blades
2. Steel plate being shaped in place
3. Plate being placed and coated with the Belzona 1311
4. Inspection after 3 years shows no significant wear

Application was carried out in accordance with Belzona Know-How System Leaflet FBC-15. Steel plates were prepared for each blade to give back some structure. These plate were bonded in with the Belzona

The customer saved \$4000 from an investment of only \$400 in Belzona because the fan didn't need to be replaced. An inspection 3 years later showed no significant wear.
