# BELZONA PROTECTS STREET SWEEPER

ID: 1349

Abrasion on the nozzle and on the duct. Customer wanted to prevent the abrasion and impact damage.

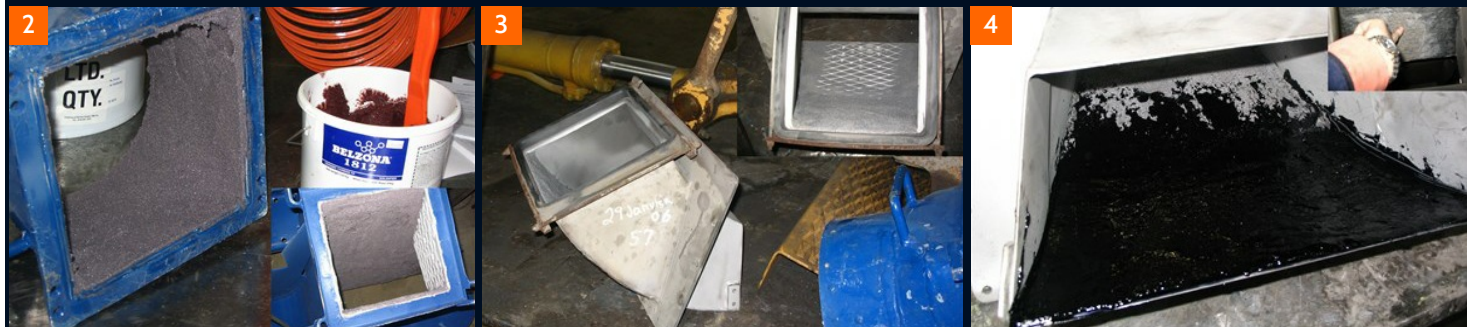
1. Example of a Elgin vehicle with the parts
2. Belzona 1812 applied on the nozzle and parts
3. The design of the busher parts receive more impact. Belzona 1812 was able to resist perforation of the elbow.
4. With the use of Belzona 2111, no more wear even after 500 hours

The application was carried out in accordance with Belzona Know-How System Leaflet SHM-8. Expanded metal was tack welded into position to assist rebuilding with Belzona® 1812. Belzona® 2111 found to give improved protection on high wear areas.

Without the Belzona, this equipment lasted less than 500 hours, one year's season (spring to fall). With Belzona® 1812 as a coating, inspection showed very small wear and was useable another season after some touch up. In some areas, impact was more severe and the use of Belzona® 2111 resulted in no wear after 500 hours.
