# STREET SWEEPER FAN PROTECTED WITH BELZONA

ID: 1350

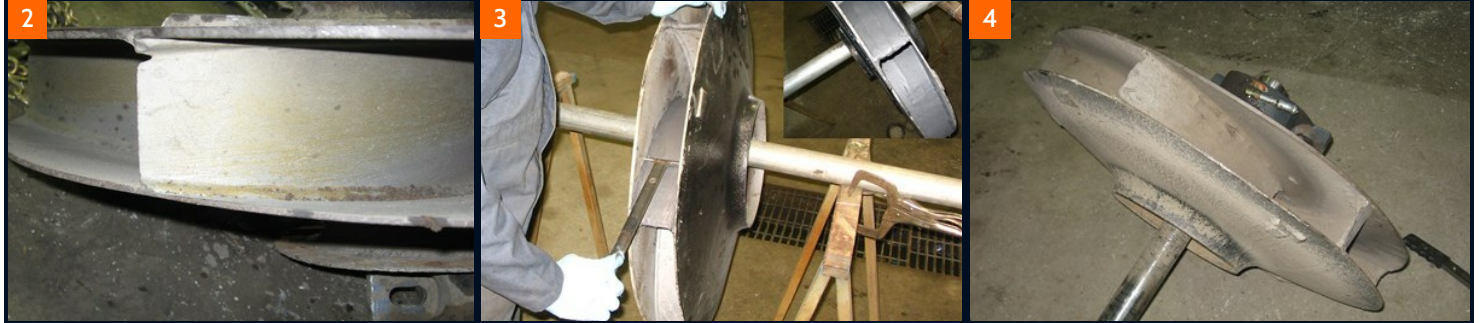
## PHOTOS

The blades on the fan are submitted to severe abrasion caused by solid particles entering the street sweeper.

1. Location of the fan on the vehicle
2. View of the damage to the fan
3. Application of Belzona 1311. The fan needs dynamic balancing before being used
4. The inspection after one year shows the Belzona 1311 in excellent shape

Application carried out in accordance with Belzona Know-How System Leaflet FBC-15. Expanded metal was used with the Belzona to re-create correct profiles.

The customer invested in 2 units of Belzona® 1311 and saved on a brand new fan which would have cost \$4000.00. After 500 hours, one season, the fan is in excellent condition and no touch up was necessary.
