# BELZONA WATERPROOFS SUNROOM ROOF

ID: 1352

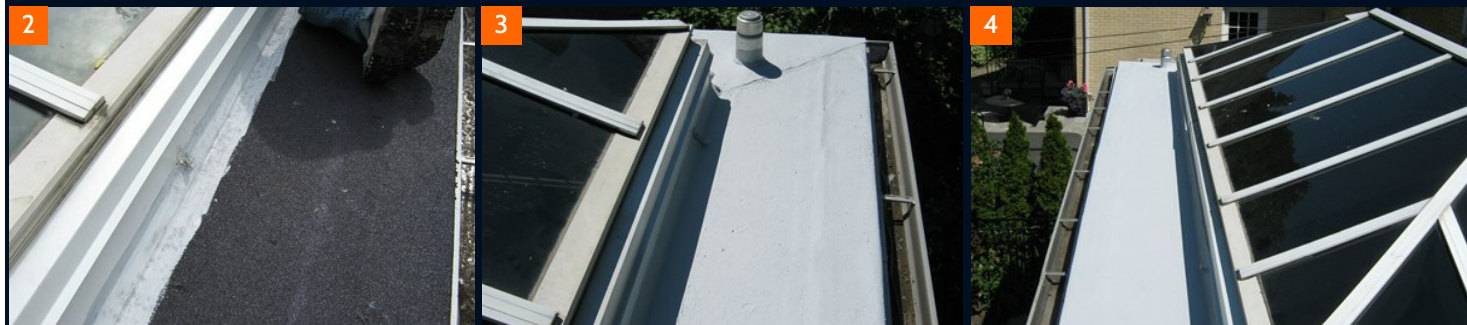
## PHOTOS

The roof and flashing on this customers sunroom was allowing water to enter and damage walls and belongings.

A poor roofing job left customer with a leaking sunroom.

1. Applying Belzona 3911 (Conditioner)
2. Initial application of Belzona 3111 incorporating Reinforcing sheet in 1st Coat
3. & 4 Finished application

Using modified Belzona Know-How Systems Leaflet RPA-1, a fully reinforced Belzona® 3111 System was applied.
