# BELZONA PROTECTS HEAT EXCHANGER HEAD

ID: 1355

Heat exchanger end cover.

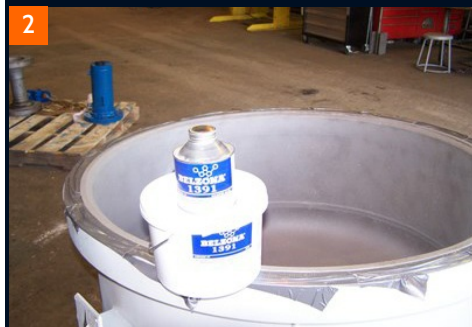
Severe corrosion occurring due to source water. corrosion rate estimated at 0.05" (1.25mm) per year.

1. The rapid metal loss through corrosion clearly evident
2. Surface preparation completed
3. Close up of application
4. Completed head
