# BELZONA REPAIR TO CLARIFIER SHAFT IS MOLDED

ID: 1356

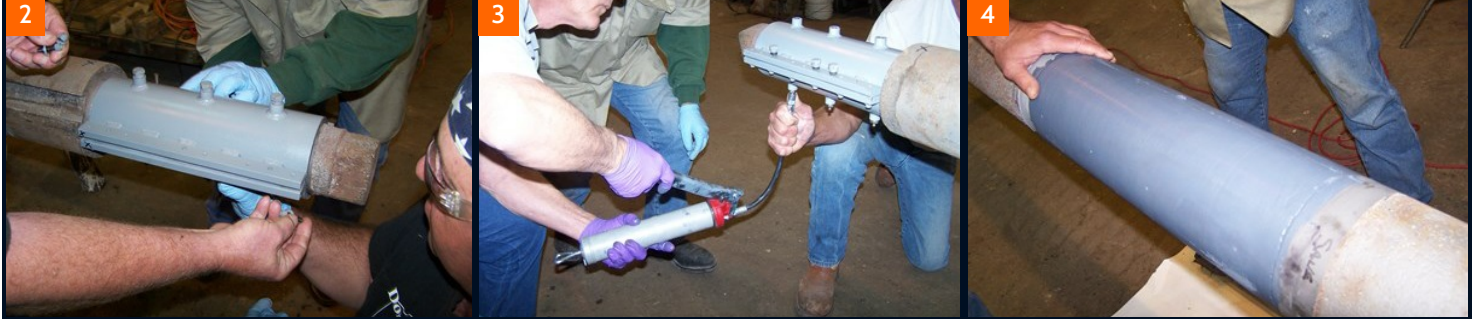
## PHOTOS

Bearing fit deteriorated due to chemical attack and abrasion. Customer needed clarifier back in service as quickly as possible.

1. The worn shaft
2. Installing the former
3. Injecting Belzona 1391
4. Finished and shaft ready to put back in service.

Application was carried out in accordance with Belzona Know-How System Leaflet MPT-2. Former was made to mold Belzona to correct diameter. Belzona was injected into the mold.
