# BELZONA REPAIRS MAIN COOLING WATER SYSTEM FLANGE

ID: 1360

Flange on seawater intake pipe of cooling system for nuclear power station

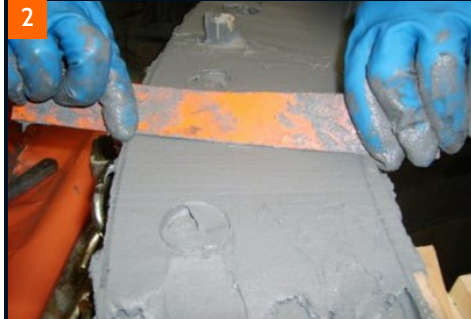
This application follows the successful coating of the pipe internals with Belzona® 1321 in 2006. After 3 years this coating had been found to be in excellent condition, when this problem arose Belzona was the first and obvious choice. Belzona has been used many times to repair damaged flanges. The only alternative available to the client was to prefabricate the spool which represented unacceptable down-time.

1. Belzona 1321 coating on puddle pipe
2. Application of the Belzona 1111
3. Machining of the cured Belzona 1111
4. The completed application

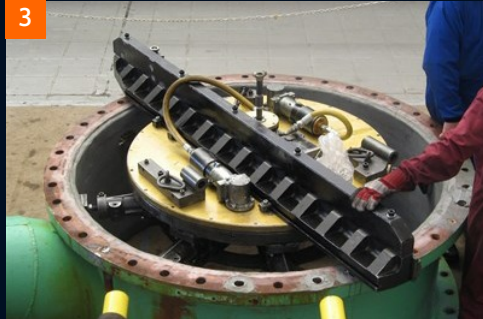
A new spool had been manufactured to connect the intake pipe to the rest of the cooling water system. During welding, the flange on this spool had become warped and following the subsequent machining was found to be up to 9mm undersized.

The application was carried out in accordance with Belzona Know-How System Leaflet VPF-13. After applying the Belzona product, on-site machining was used to achieve correct dimensions.
