# BELZONA KEEPS THE BEANS DRY

ID: 1361

75 ft. diameter soybean storage bin

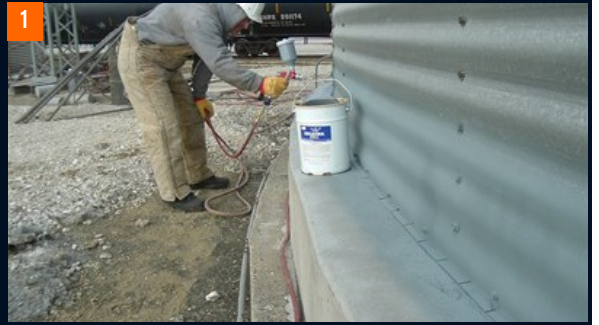
1. Belzona 6111 applied and Belzona 3921 being applied
2. First coat of Belzona 3111 with Reinforcing sheet being applied
3. Completed application
4. Completed application, general view
