# BELZONA RESTORES RIVER WATER PUMP

ID: 1362

River water intake pump for water treatment plant.

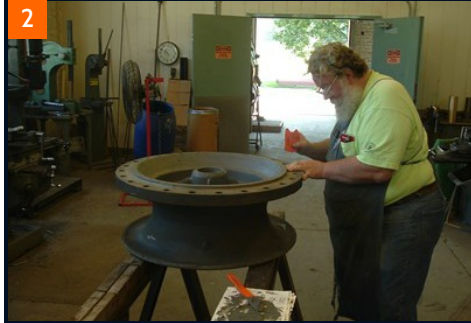
Erosion corrosion caused by sand and solids drawn from the river.

1. Damaged area on pump
2. Repairs underway with Belzona 1111
3. Rebuild completed with Belzona 1111
4. Completed application after application of Belzona 1321
