# PUMP DIFFUSER REPAIR SURPASSES ALL EXPECTATIONS WITH BELZONA

ID: 1368

Sea water cooling system pump for a 60 MW turbine.

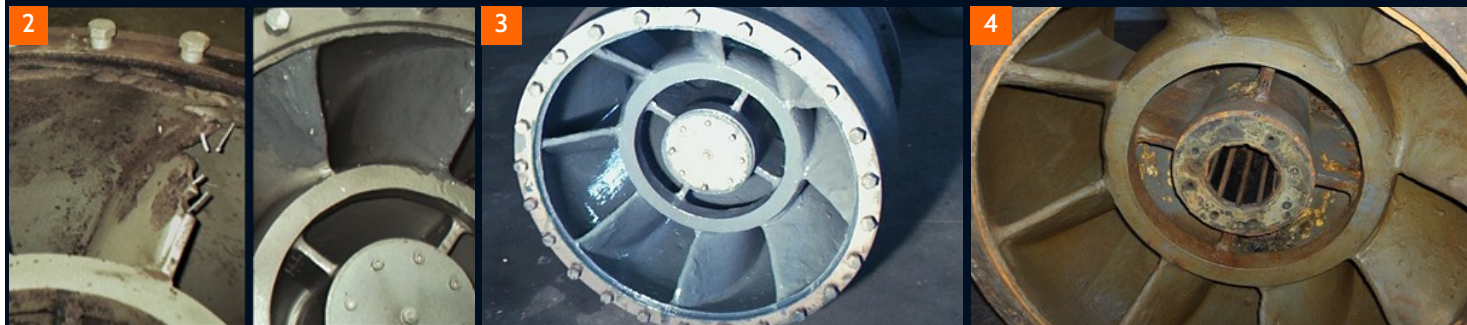
Efficiency losses and pump breakdown due to severe erosion-corrosion of the single vertical axial flow pump (7090 m<sup>3</sup>/h). Prior to the Belzona solution, the client had to replace the pump components annually. As a significant local electricity supplier, downtime of this critical equipment caused major problems.

1. Condition of the pump diffuser after 1 year in service
2. Rebuilding of the vane profiles
3. The finished application
4. Application after 9 years service

The customer was surprised that the eroded equipment could be repaired and delighted with the vastly improved reliability and performance. The pump casing and suction bell were also coated and protected internally and externally. After 9 years in service, the coating was found to still be in excellent condition.
