# BELZONA KEEPS THE SHOWERS HOT & CLEAN AT HOTEL

ID: 1370

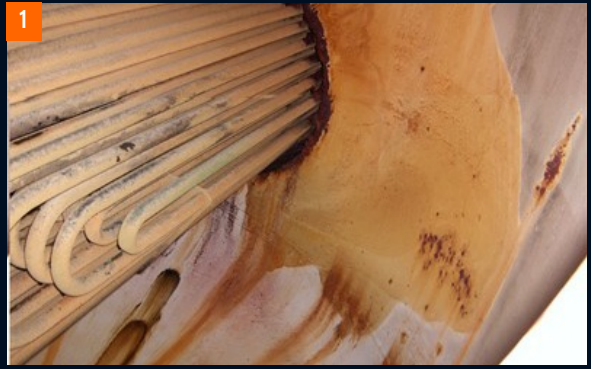
Breakdown of the original coating system had resulted in severe corrosion, deep pitting and through holes around the heating bundle. In addition the corrosion led to discolouring of the hot water supply in this prestige international hotel, leading to customer complaints.

1. Corrosion damage after failure of the original coating
2. Tube bundle nozzle, before preparation for coating
3. Completed application
4. Inspection after 8 months in service

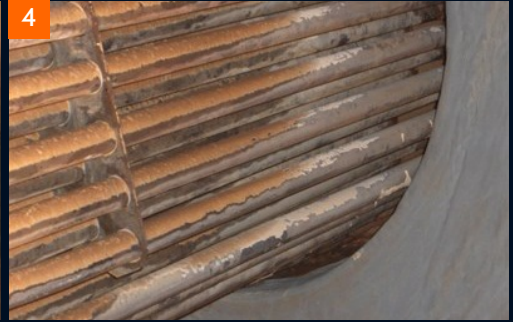
The client was looking for a quick and economic long term solution to this image damaging problem. Only the affected area was rebuilt and the Belzona coating overlapped onto the original coating. An initial inspection after 8 months showed no breakdown and the solution was subsequently applied to the second calorifier. After 4 years in operation the hotel maintenance manager confirmed that the Belzona coating is in the same perfect condition.
